Contract Report GL-95-1
September 1995

Acoustic Emission on Cofferdam Distress Warning System and Ancillary Acoustic Emission Monitoring; Melvin Price Locks and Dam (Phase III)

by Ground Engineering, Inc.

Final Report

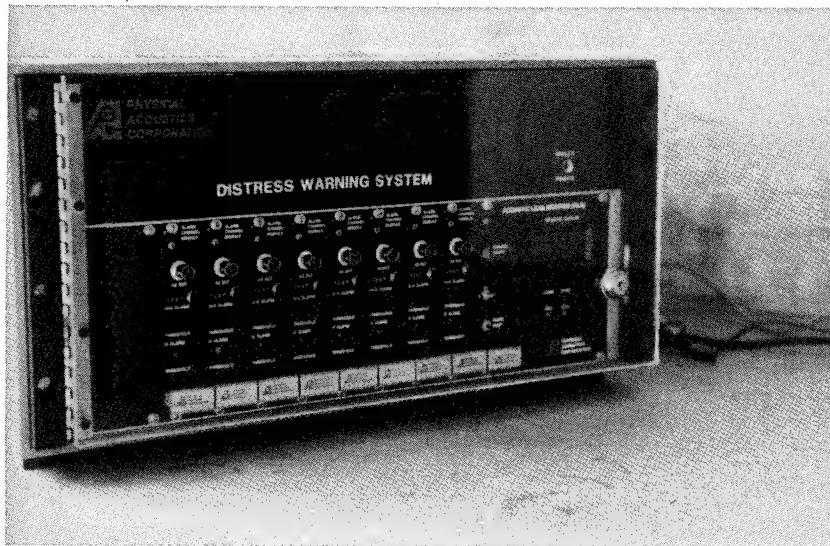
Photo # 1 - Distress Warning System (DWS)

The DWS was a multichannel acoustic emission monitoring system supplied by Physical Acoustics Corporation (PAC), Lawrenceville, New Jersey, see Photos 1 and 2. It was intended for use as a continuous and unattended monitoring unit. The basic system was composed of a PAC ALM-8, an 8 channel AE monitoring system; an uninterruptible power supply capable of providing up to 3.5 hr of back-up power in the event of power failure; and a security monitoring system and telephone dialer which was capable of calling four numbers sequentially and reporting an Alarm (Alert) Message. Telephone transmission was provided by a standard cellular mobile telephone.

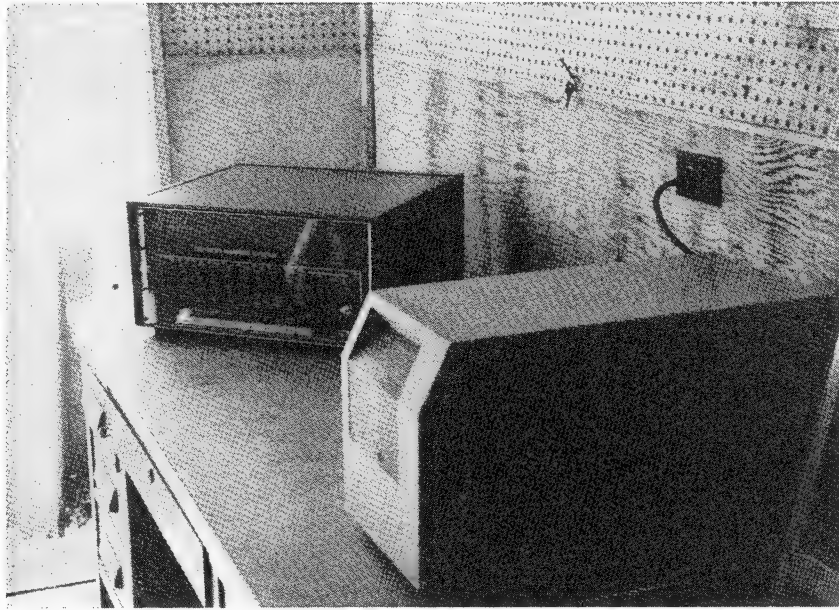
Photo #3 - DWS and Uninterruptible Power Supply

4.2.2.3 Uninterruptible power supply. The Uninterruptible Power Supply (UPS) supplied as a part of the DWS was Micro-Ferrups Model ME 500VA/350W as manufactured by Best Power Technology, Necedah, Wisconsin, see Photo 3. The UPS was capable of providing consistent AC power to the DWS during both "brown-out" and "black-out" conditions. It was a stand-alone unit that monitored input AC power and instantly supplied power to the DWS during power fluctuations and outages. It was capable of supplying such emergency power for a period of up to 3.5 hr. In addition the UPS had alarm circuits of its own that could be monitored and reported on by telephone. These alarm circuits were not utilized in the DWS.
